Specimen ID: UTA-1

Test Location: University of Texas, Austin

Reference: "Experimental Investigations of Beam-Column Subassemblages", *Report No. SAC 96-01*, March 1996.

MATERIAL PROPERTIES AND SPECIMEN DETAILS

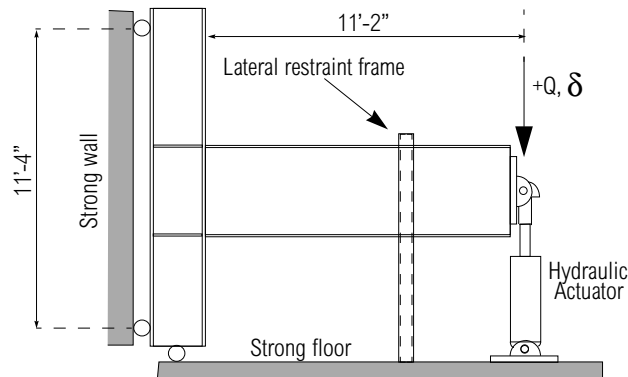
TEST SET-UP

| Member | Size | Grade | Yield Stress (ksi) | | Ultimate Strength (ksi) | |
|---|--|---|---|---|---|---|
| Boundary conditions | Single-sided test, no floor slab, axial force in lower half of column equal to beam shear force, specimen tested in upright position | | | | | |
