Specimen ID: UTA-3
 Keywords: Pre-Northridge, simulated field welding, weld fracture, column flange fracture, shear tab fracture, small rotation capacity
 Test Location: University of Texas, Austin
 Test Date: March 16, 1995
 Principal Investigator: Michael D. Englehardt; with Bradley D. Shuey and Thomas A. Sabol
 Related Summaries: 23
 Reference: "Experimental Investigations of Beam-Column Subassemblages", *Report No. SAC 96-01*, March 1996.
 Funding Source: FEMA / SAC Joint Venture, Phase 1

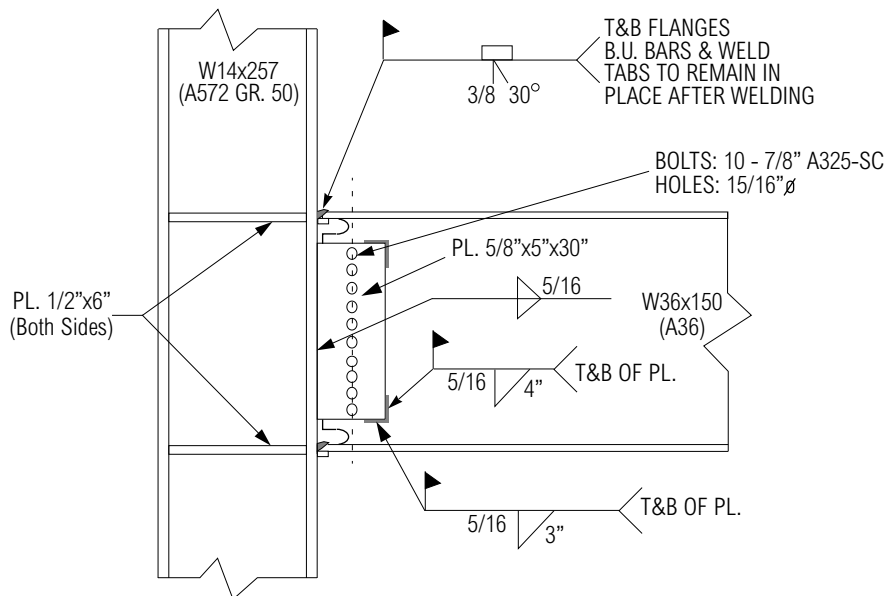
CONNECTION DETAIL

Member	Size	Grade	Yield Stress (ksi)		Ultimate Strength (ksi)	
			mill certs.	coupon tests *	mill certs.	coupon tests *
Beam	W36x150	A36	58.5	42.3 flange 47.7 web	67.5	61.1 flange 63.4 web
Column	W14x257	A572 Gr. 50	53.5	48.7 flange	72.5	69.0 flange
Welding Procedure Specification	Fillet Weld: FCAW-SS; 0.072" diameter AWS E71T-8 electrode; conforms with AWS 5.20 specification and Section 4.2 of AWS D1.1-94 CJP groove weld: FCAW-SS; 0.120" diameter AWS E70T-4 electrode; conforms with AWS 5.20 specification and Section 4.2 of AWS D1.1-94					
Shear tab	5/8"x30"x5" plate with ten 7/8" A325 bolts					
Panel zone	No doubler plates					
Continuity plates	1/2" plates with c.p. weld					
Boundary conditions	Single-sided test, no floor slab, axial force in lower half of column equal to beam shear force, specimen tested in upright position					
Other detailing	Leave backup bars and weld tabs in place, root defects determined from UT inspection left in place

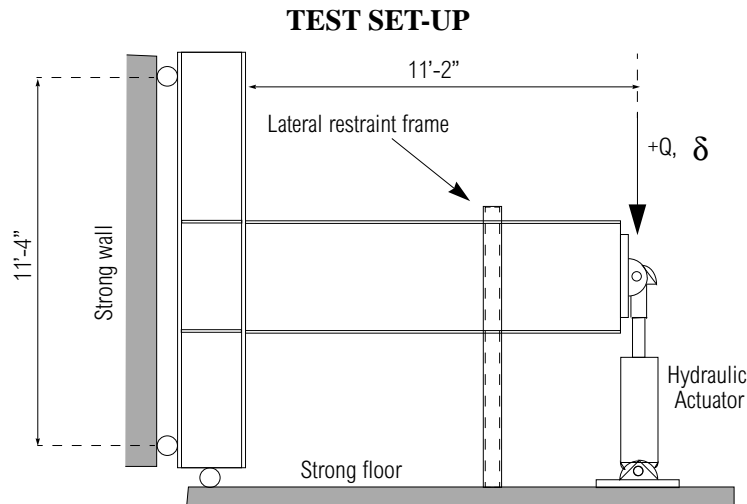
DISPLACEMENT HISTORY AND KEY EXPERIMENTAL OBSERVATIONS

Applied Displacement History	Key Observations of the Test	
<p style="text-align: center;">$\delta_y = 1.0$ in. (analytical, original specimen)</p>	Point	Description
	1	Minor yielding of beam flanges
	2	Beam flange yielding becoming more pronounced
	3	Fracture across weld between beam bottom flange and column flange, becoming a column “divot” fracture on one side of beam web; fracture of lower part of the shear tab extending to the first bolt hole

Mode of failure: Fracture of the beam bottom flange connection during the first positive displacement excursion to $2\delta_y$.

Specimen UTA-3 failed in the first half of the first cycle to $2\delta_y$ at a beam tip displacement of 1.81 in. Prior to failure, yielding of the beam flanges was noted during the displacement excursions to $0.75\delta_y$ and $1\delta_y$. Failure occurred when a fracture developed in the welded connection between the beam bottom flange and the column flange at a displacement of 1.81 in. On the left half of the beam bottom flange, the fracture propagated along the weld-column interface; on the right half of the beam flange, the fracture propagated into the column flange face in a crescent/divot shape. The divot fracture extended from the weld root and terminated inside the column flange. The fracture appeared to reach a depth of 1 in. in the column flange. The shear tab also fractured from the bottom edge to the first bolt hole. The specimen experienced negligible yielding, and the maximum plastic rotation of joint was approximately 0.3% radian.
