the FEMA Program to Reduce the Earthquake Hazards of Steel Moment Frame Structures

Specimen ID:	UCSD-2R
Keywords:	Repaired, replacement plate for beam top flange, shear tab to column weld, web buckling, flange fracture, low rotation capacity
Test Location:	University of California, San Diego
Test Date:	April 21, 1995
Principal Investigator:	Chia-Ming Uang; with Duane Bondad
Related Summaries:	5
Reference:	"Experimental Investigations of Beam-Column Subassemblages", <i>Report No. SAC 96-01</i> , March 1996.
Funding Source:	FEMA / SAC Joint Venture, Phase I

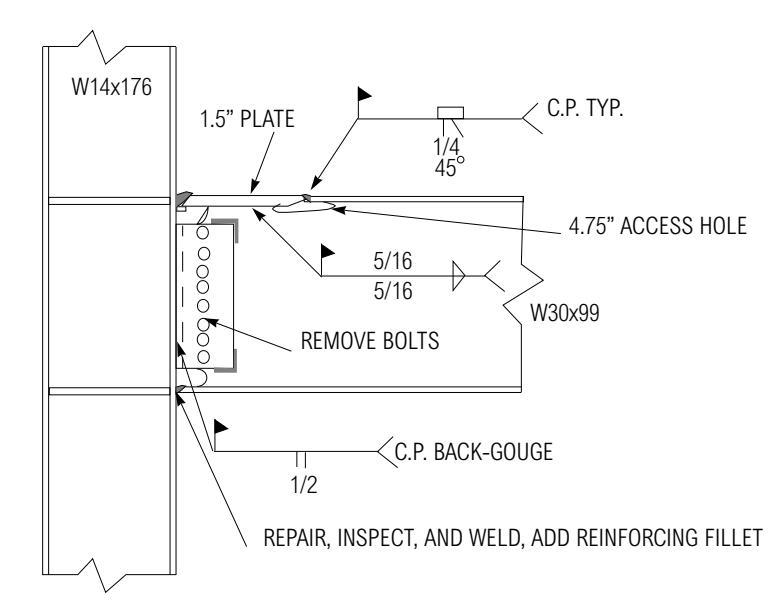
CONNECTION DETAIL

0.072 in. diameter AWS E71-T8 electrode.						
Shear tab	3/8 x 5" plate, remove bolts, groove weld beam web to column flange						
Panel zone	No doubler plates						
Continuity plates	3/8" plates with c.p. weld						
Boundary conditions	Single-sided test, no floor slab, axial load in lower half of column equal to shear in beam, speci-						
	men tested in upright position						
Other detailing	Repair beam bottom flange groove weld						
$N_{A} = not available$	*				* Coupon loca	tions per ASTM

The specimen repair procedure consisted of torch cutting and removing a 20-in. long portion of the beam top flange which had buckled, torching a 4.75 in. wide inclined access hole, replacing the cut beam top flange with a 1.5" thick plate, welding the replacement plate to the column and beam flanges, fillet welding the plate to the beam web, removing the backup bars and running a final weld pass, removing the shear tab bolts, groove welding the beam web to the column flange, and repairing the beam bottom flange to column flange groove weld. The standard SAC/ATC-24 loading history was used in the quasi-static testing of the repaired specimen, and a yield displacement (δ_y) of 1.40 in. was assumed to provide consistency with the previous test.

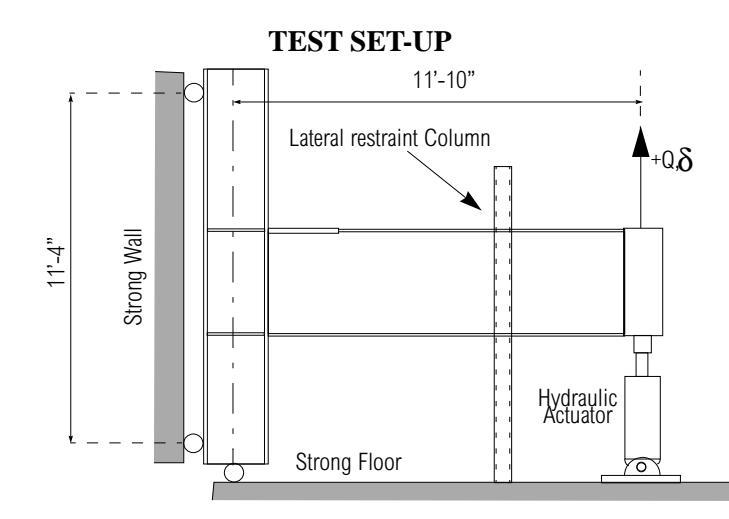
DISPLACEMENT HISTORY AND KEY EXPERIMENTAL OBSERVATIONS

Applied Displacement History		Key Observations of the Test		
-1.4 in^{δ} (analytical original specimen)	Point	Description		
	1	Yielding and minor local buckling of beam flanges		
$ \underbrace{\begin{array}{c}3\delta_{y}\\\Xi\\2\delta_{y}\end{array}}_{2\delta_{y}} \underbrace{1}_{\Box}\underbrace{2}_{J}\underbrace{2}_{J}\underbrace{1}_{J}$	2	Out of plane buckling of the beam web below top access hole		
	3	Significant local buckling of beam top flange next to flange replacement plate and tearing at both ends of access hole at top repair		
$\begin{bmatrix} -2\delta_y \\ -3\delta_y \end{bmatrix} = \begin{bmatrix} -2\delta_y \\ -3\delta_y \end{bmatrix} = \begin{bmatrix} -2\delta_y \\ -2\delta_y \end{bmatrix} = \begin{bmatrix} -2$	4	Fracture of groove weld between beam top flange and replacement plate at access hole

Mode of failure: Fracture of the groove weld at the beam top flange above the access hole for the replacement plate during the $3\delta_v$ cycle.

Yielding and minor local buckling in the beam flanges of specimen UCSD-2R were observed during displacement cycles of $2\delta_y$. When the top half of the beam web was in compression, the web below the 4.75 in. wide access hole buckled out of plane. This resulted from the transformation of the beam web from a stiffened to an unstiffened element, due to the presence of the access hole. During the excursions to $3\delta_y$, significant local buckling of the beam top flange next to the flange replacement plate was observed, while the buckling of the beam bottom flange was limited. During the first positive excursion to $3\delta_y$, the out-of-plane web buckling caused tearing at both ends of the access hole. Once the tearing initiated, it propagated rapidly in the next cycle. The beam top flange above the access hole fractured completely in the subsequent excursion. In the panel zone, plastic shear deformations only developed when the top flange was subjected to tension; local buckling limited compression force transfer in the beam top flange. The maximum plastic rotation of the connection was approximately 2.6% radian. The repair scheme did not significantly improve the performance of the connection, as is noted from the nearly equal plastic rotation capacity of the original and the repaired specimens, although the plastic zone was moved away from the column face. It is important that the large weld access hole in the repair be stiffened to achieve better performance.
