Specimen ID: UTA-1

Test Location: University of Texas, Austin

Reference: "Experimental Investigations of Beam-Column Subassemblages", *Report No. SAC 96-01*, March 1996.

MATERIAL PROPERTIES AND SPECIMEN DETAILS

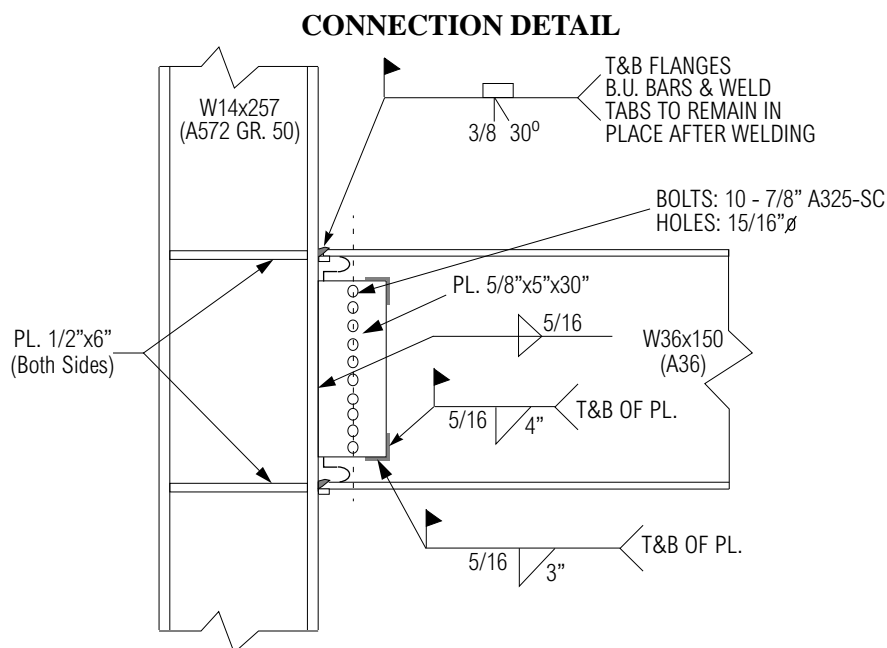
Specimen UTA-1 failed suddenly in the first half of the second loading cycle to a displacement of $1\delta_y$ (+1.0 in.) when a fracture developed in the weld between the beam bottom flange and the column flange. On one side of the beam web the fracture ran along the weld/column interface line, while on the opposite side of the web it extended from the weld root into the face of the column flange, carving out a crescent-shaped divot from the flange. A small crack also developed in the lower portion of the shear tab that extended up to the first bolt hole.

After this initial failure occurred, the specimen was brought back to its initial position and then displaced to +2.5 in. This half-cycle of loading caused the divot to pull away from the column face, revealing the depth of the fracture to be approximately 1 in. The vertical portions of the supplemental fillet welds between the shear tab and the beam web also fractured during this half-cycle.
